PERMAFROST AND TERRAIN RESEARCH AND MONITORING: NORMAN

WELLS PIPELINE : Volume II - Research and Monitoring

Permafrost and Terrain Research and Monitoring: Norman Wells Pipeline

**Volume II
Research and Monitoring Results:
1983-1988**

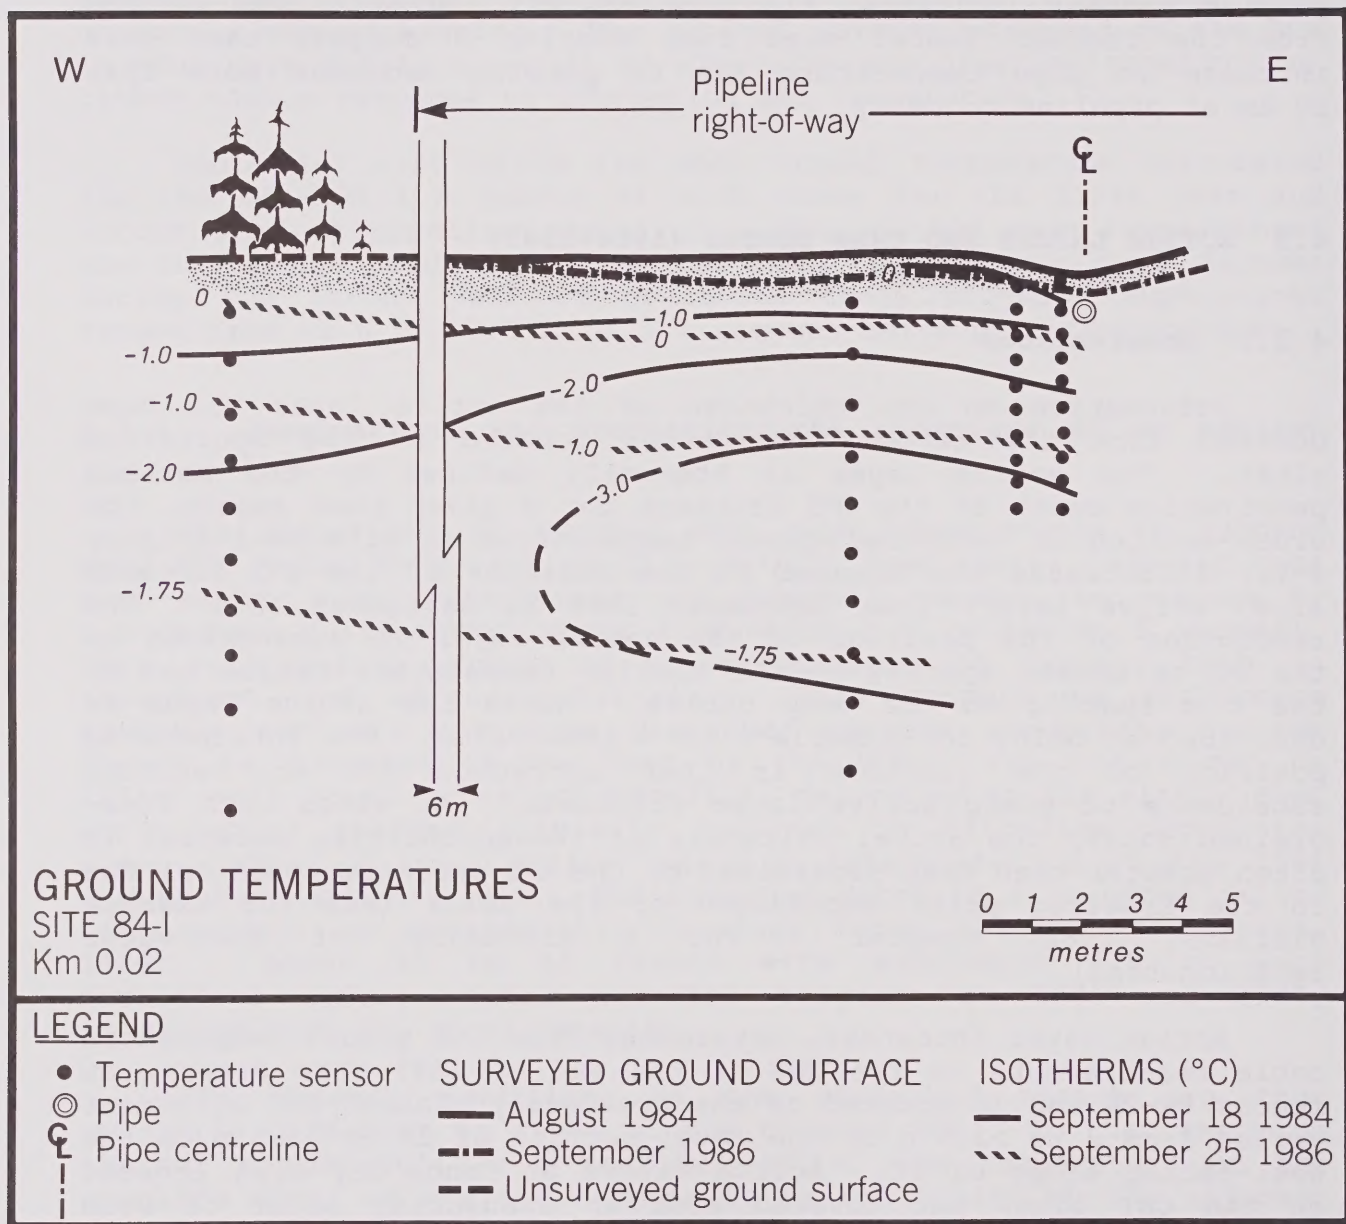
Figure 4-11. Site 84-1: Ground temperature isotherms, September 1984 and to September 1986. The 0°C isotherm represents the position of the active layer.

The 0°C isotherm on-ROW has deepened by up to >1 m from 1984 to 1987 in response to clearing and construction activities; by comparison off-ROW active layers have changed very little over this period. Warm thin (1-2 m) permafrost has disappeared beneath the ROW at two southern fences (85-9 and 85-11), both underlain by ice-poor coarse grained soils. The ground thermal response in ice-rich terrain and in thick ice-rich peat sites has generally been slow due to latent heat effects. Although little change in permafrost temperature has occurred at these sites, active layers have deepened.

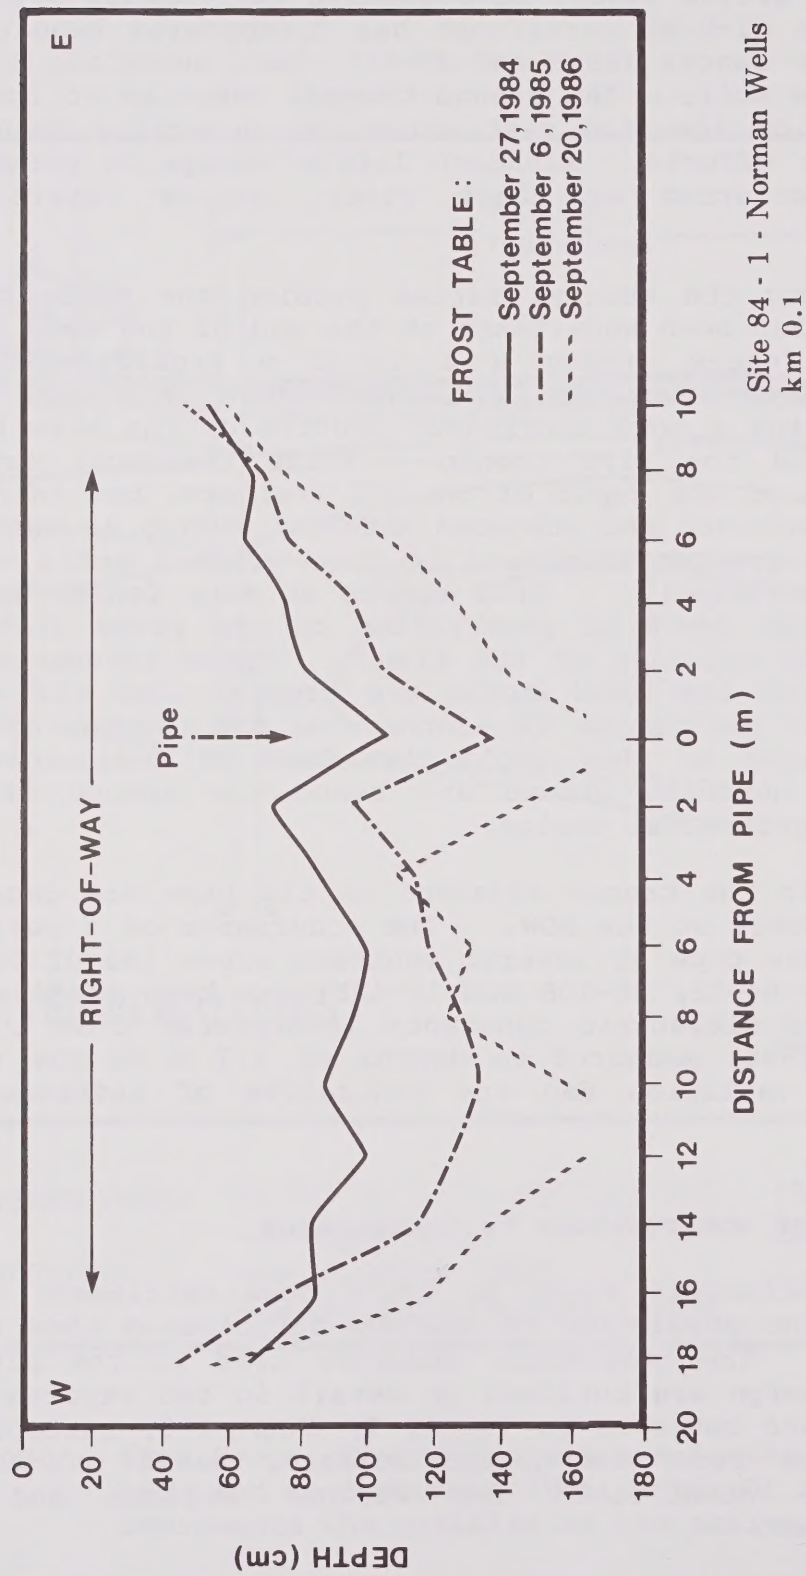
Figure 4-12. Site 84-1, km 0.02: Fall transects probing to the frost table.

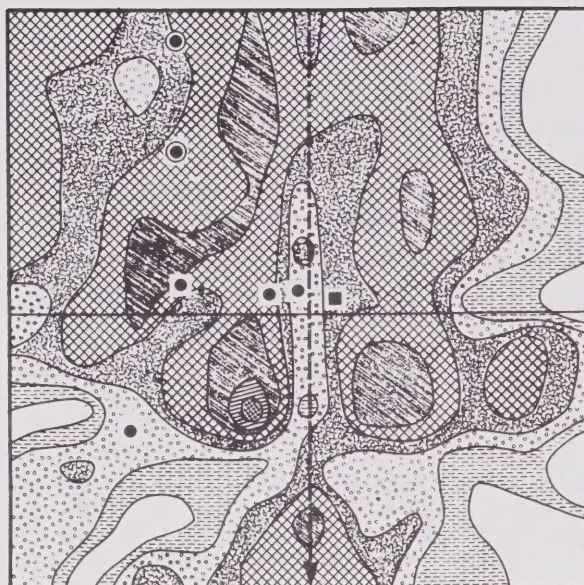
Site 84 - 1 - Norman Wells
SURFACE ELEVATION CHANGE (cm)
June 20 1984 - September 17 1986

At site 84-1 cumulative settlement of 40 to 60 cm has occurred across much of the right-of-way since June 1984. Settlement is continuing, but at a reduced rate compared to the first year of observation. At site 84-3A, cumulative settlement of 20 to 40 cm has occurred since the August 1984 survey. Although settlement is continuing to occur, comparison of data from successive surveys suggest that the rate of surface movement is decreasing. At site 85-8C, cumulative settlement of up to 120 cm in the trench area and 100 cm on the right-of-way has been recorded since May 1985. Across most of the ROW cumulative settlement is <40 cm. This site shows an irregular rate of settlement, probably reflecting variations in the thickness of the insulating peat surface layer and in the ice content of underlying sediments.

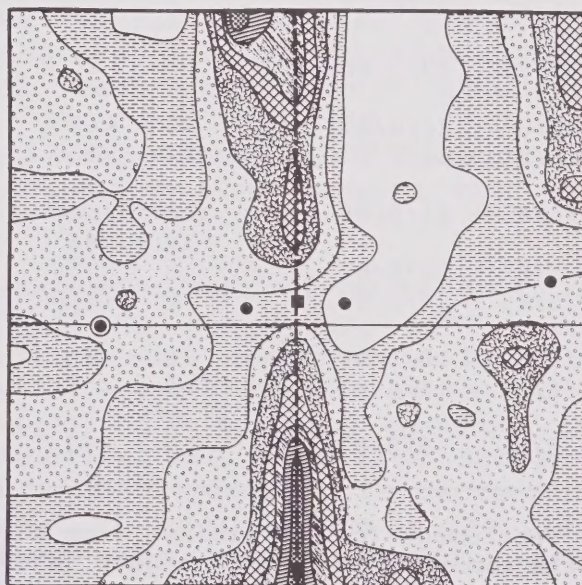
Site 85 - 7B - Table Mountain
SURFACE ELEVATION CHANGE (cm)
May 26 1985 - September 16 1986

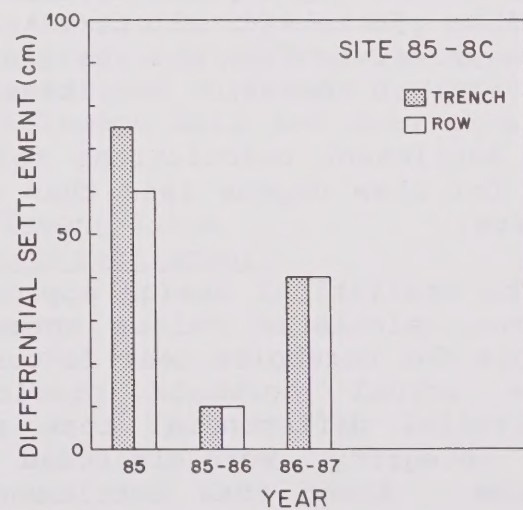
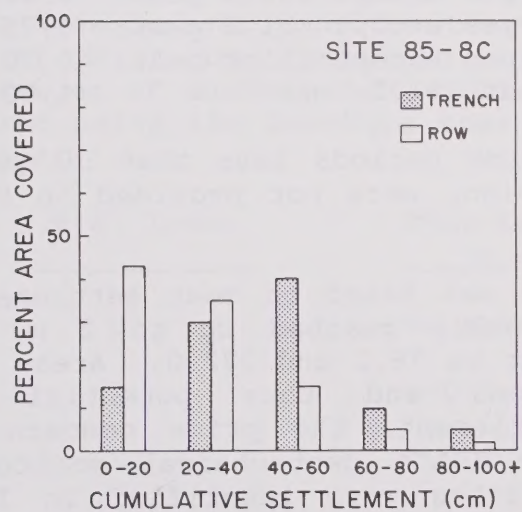
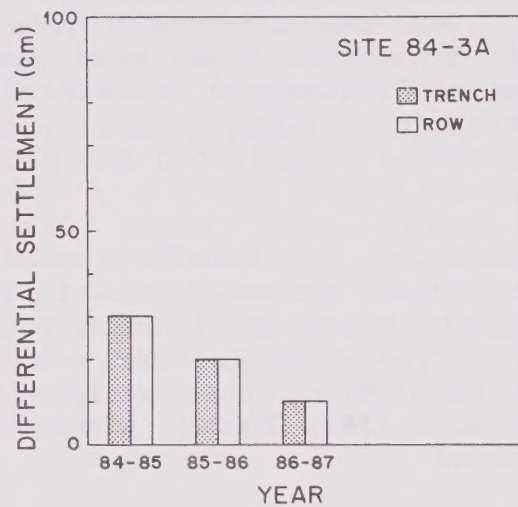
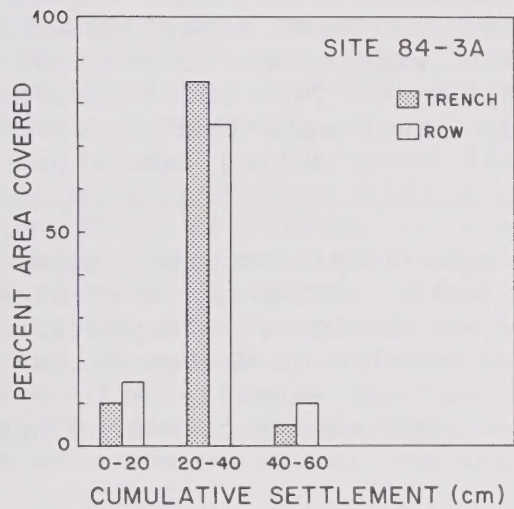
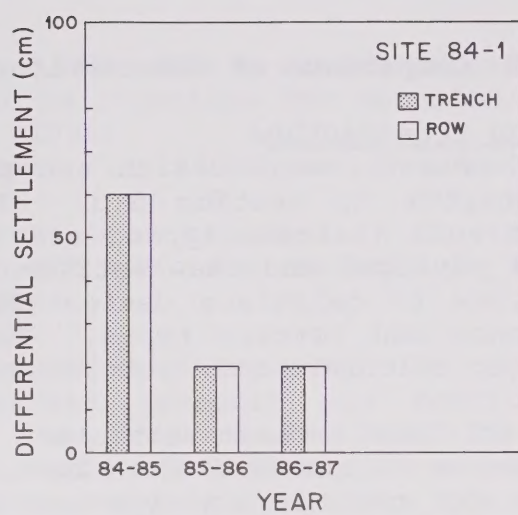
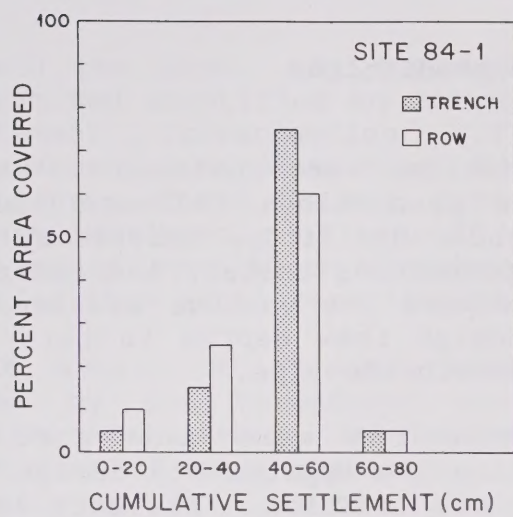
Figure 4-15. Surface settlement at sites 84-1, 84-3A and 85-8C recorded in terms of cumulative settlement by percent area to August 1987 (left), and range of settlement measured between successive surveys (right).

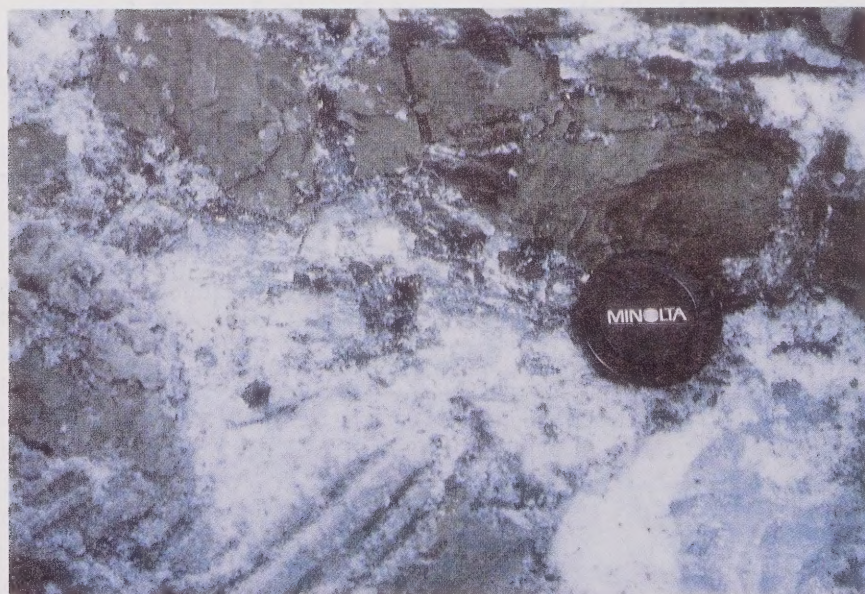
Figure 5-2. Irregular lenses and masses of ground ice in glacial till exposed in a side slope cut, km 133. (21/01/84).

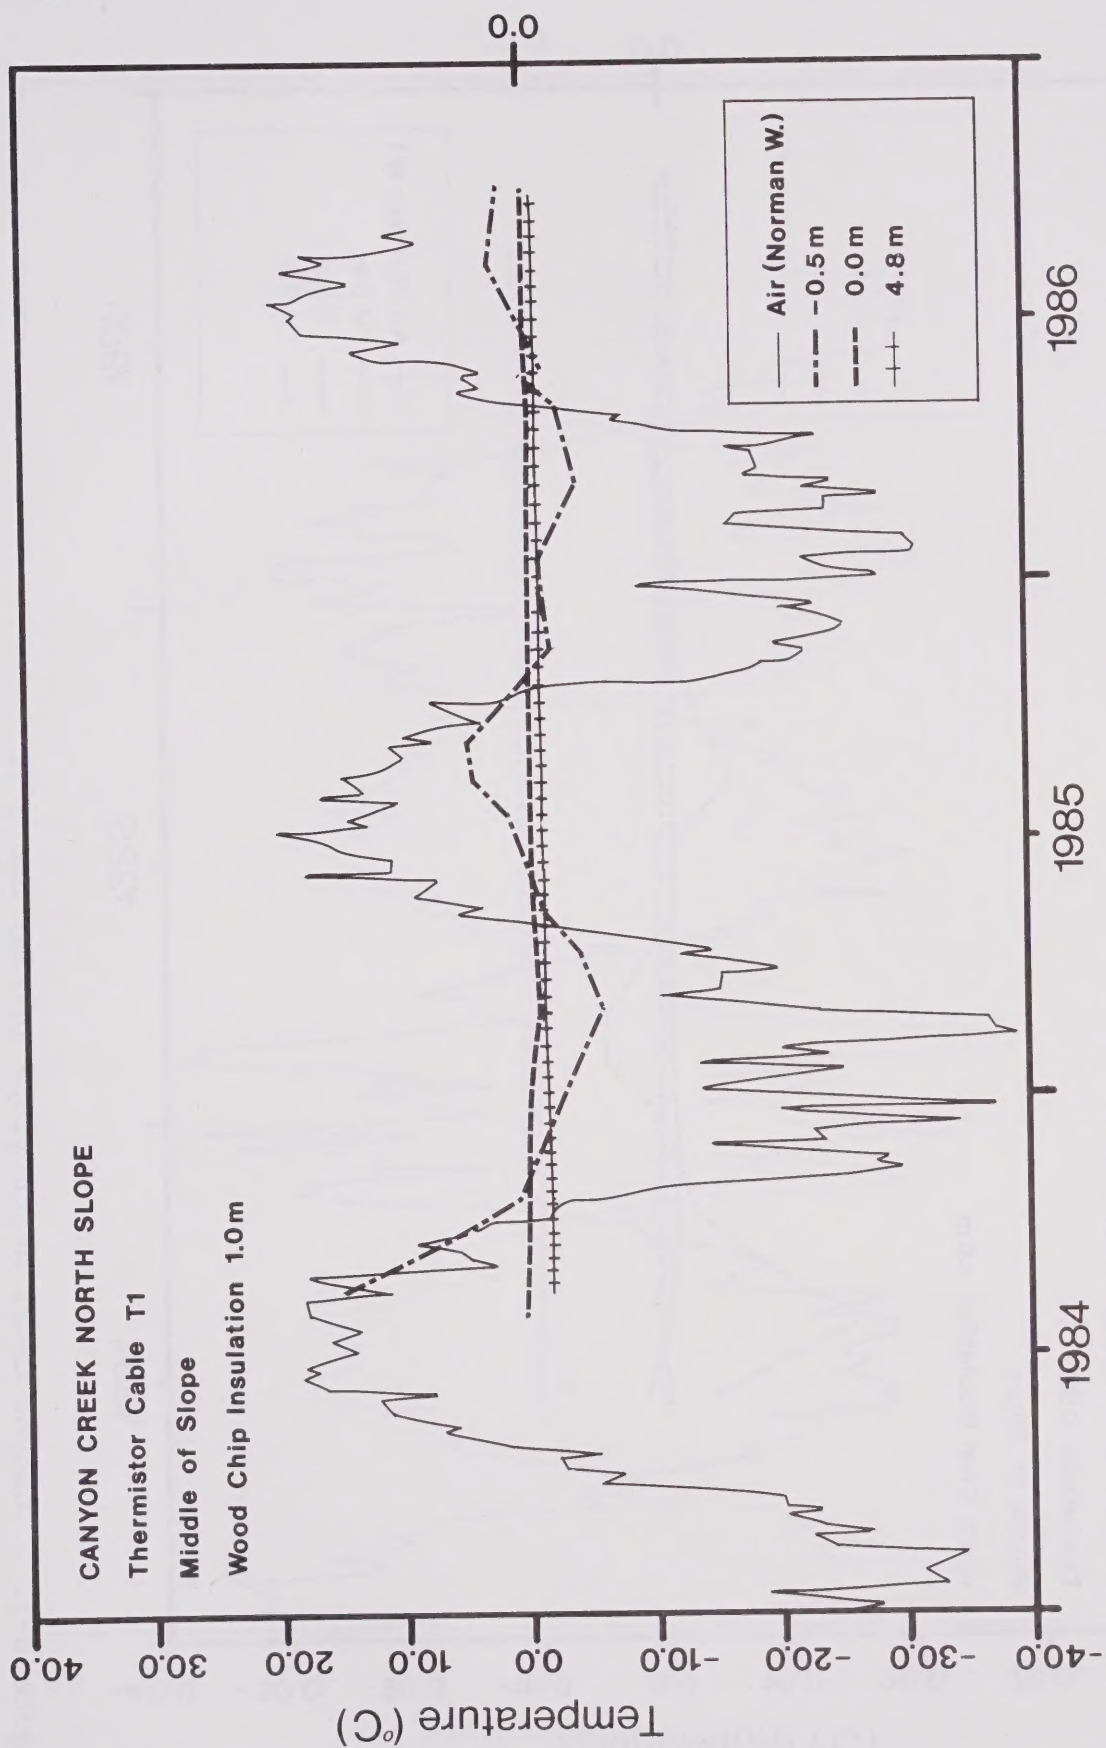
Canyon Creek (INAC/EMR Site 84-2B, slope 3) is a unique site in that a thermal fence was installed across the right-of-way about the middle of the wood chip slope; this is the only government instrumented wood chip slope and it includes an off right-of-way cable. This thermal fence has three cables on the right-of-way and a control thermistor cable (Cable T4) in an uncleared area west of the right-of-way. The three cables on the right-of-way extend below a 1 m wood chip layer. At Great Bear River (slope 29b) there

Figure 6-2. Canyon Creek North slope (84-2B) cable T1.

are two cables in the wood chip cover. One is located near the top of the slope (Cable TA-17) and the other is located near the middle of the slope (Cable TA-15). At both of these sites, self-heating was most intense at the mid-height level of the insulation layer during the first summer period and was less evident during the second and third summer periods.

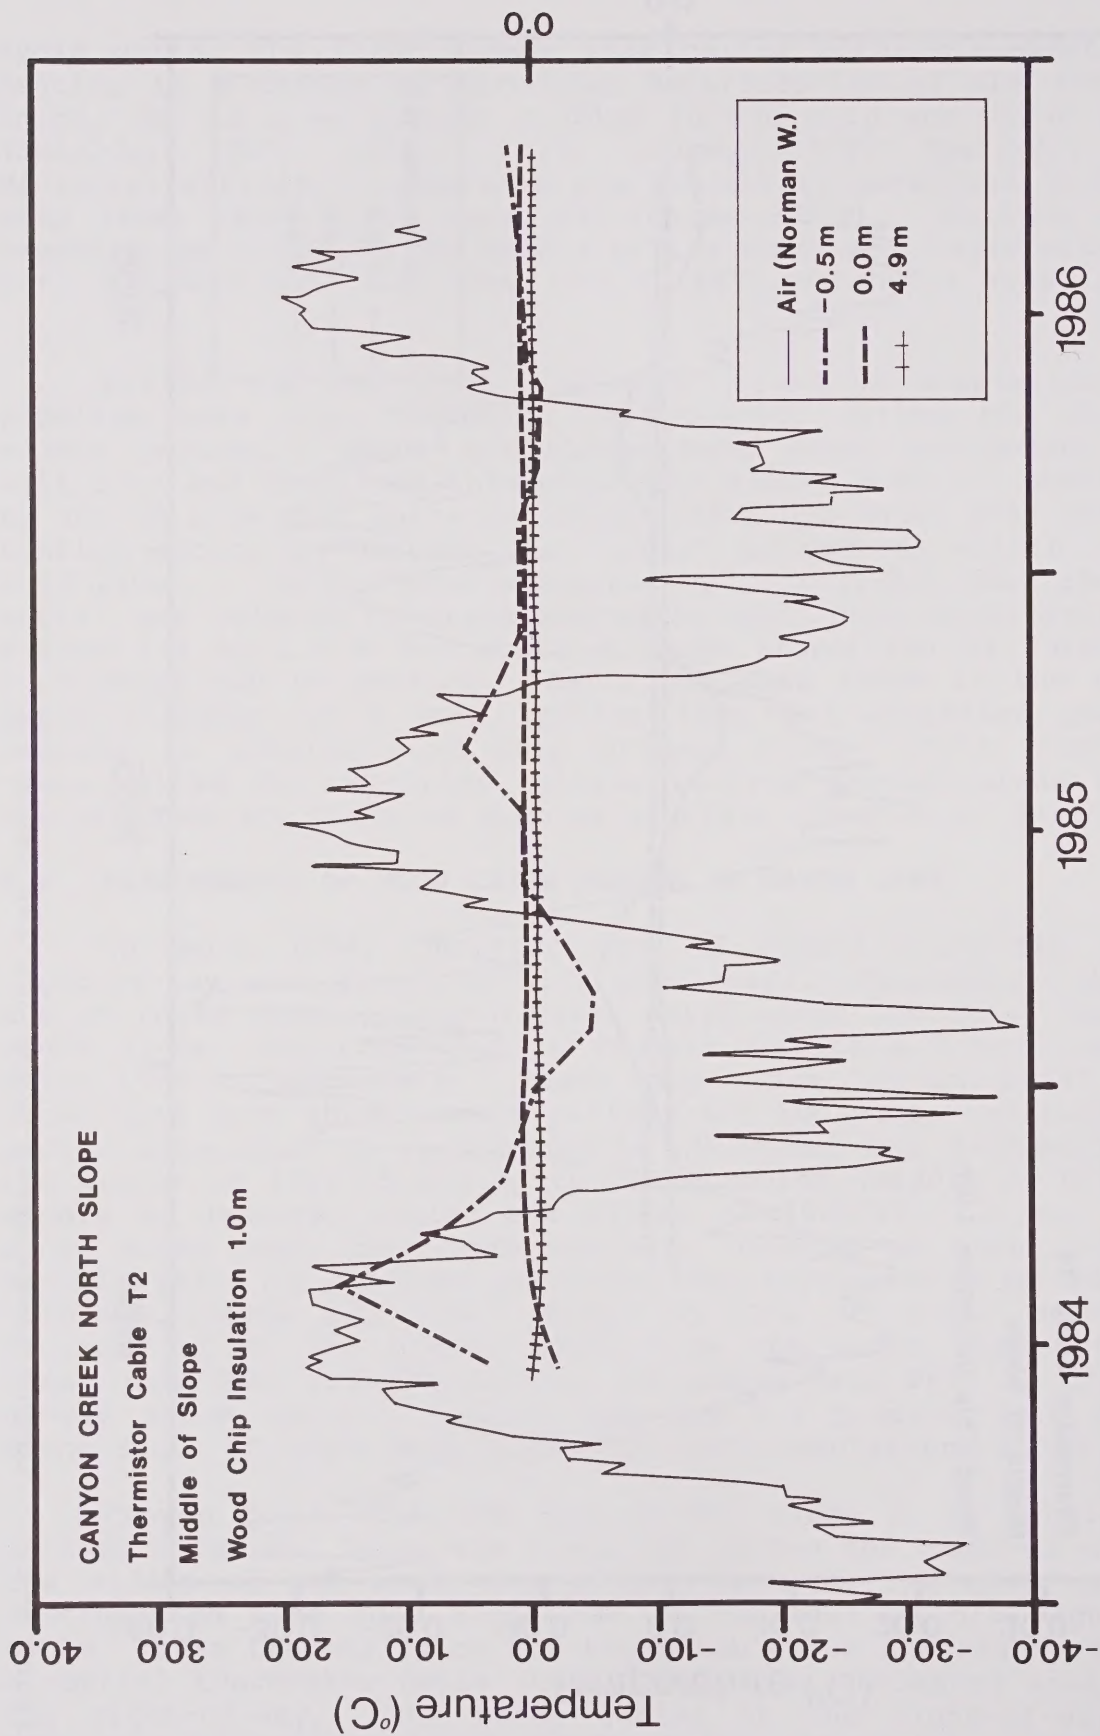
Figure 6-3. Canyon Creek North slope (84/2B) cable T2.

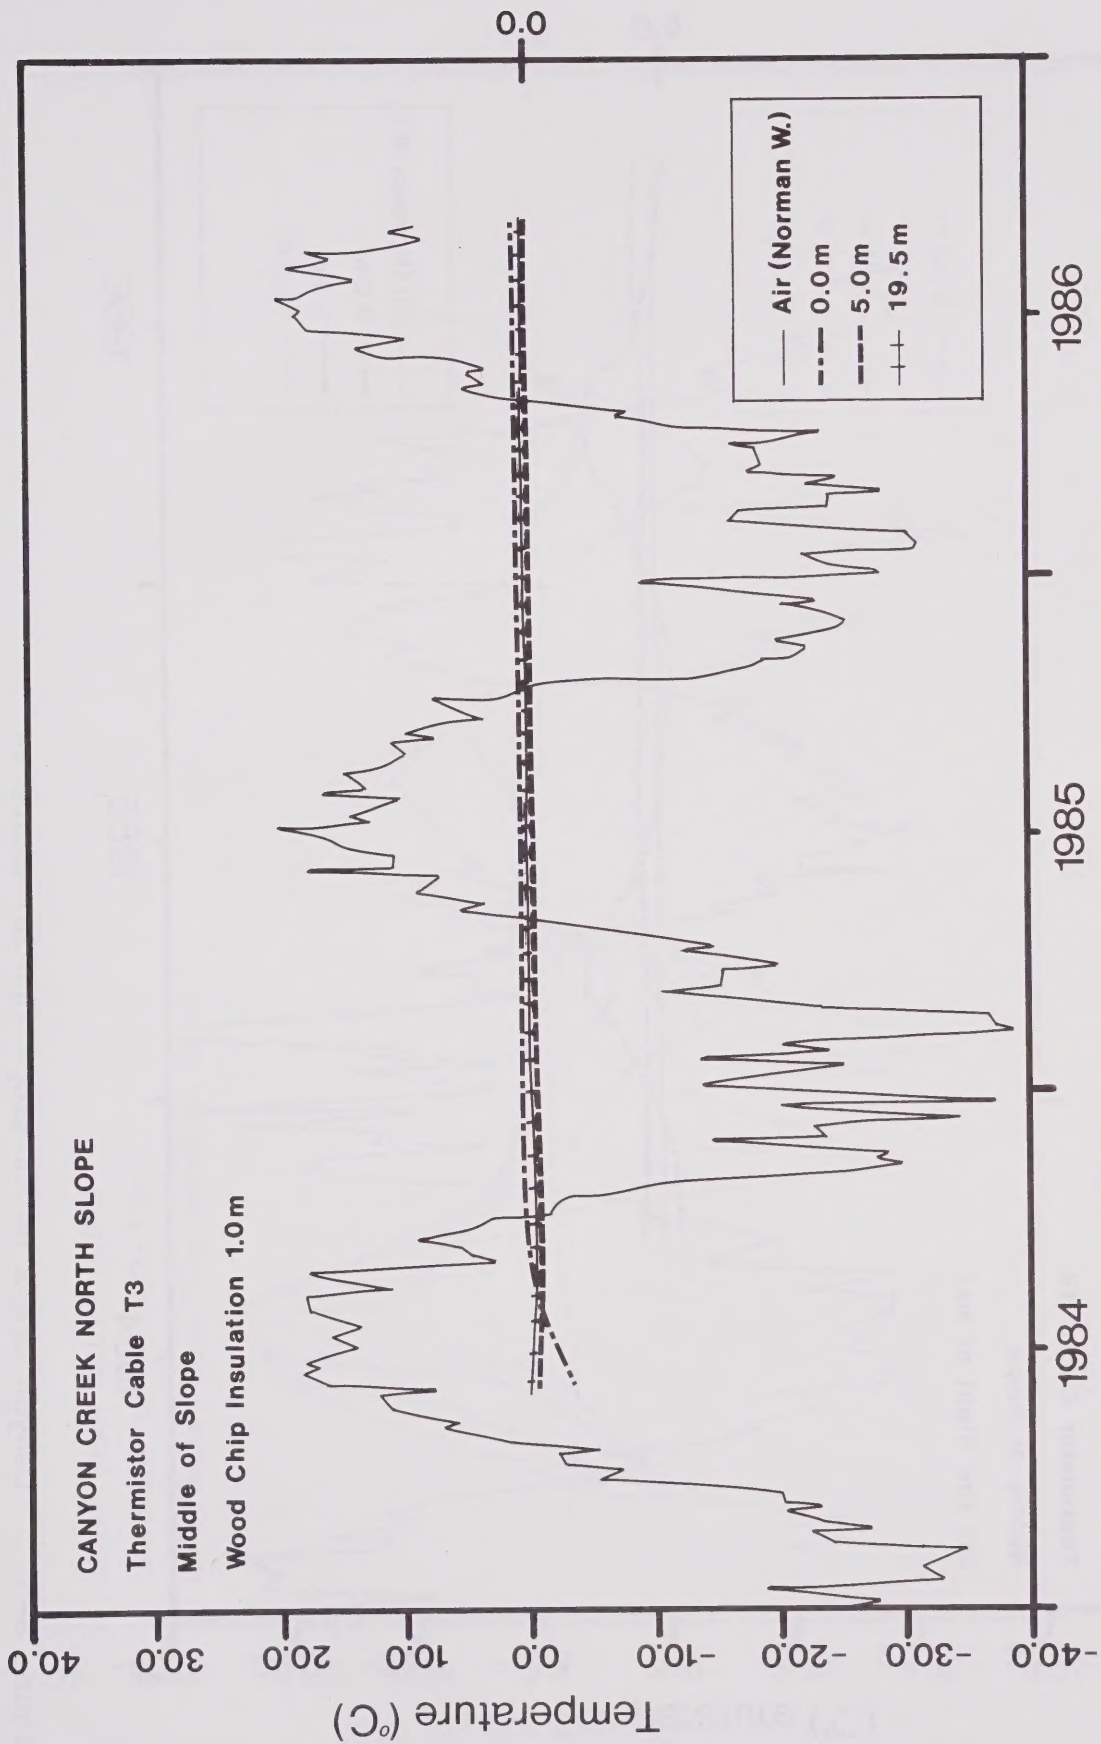
Figure 6-4. Canyon Creek North slope (84-2B) cable T3.

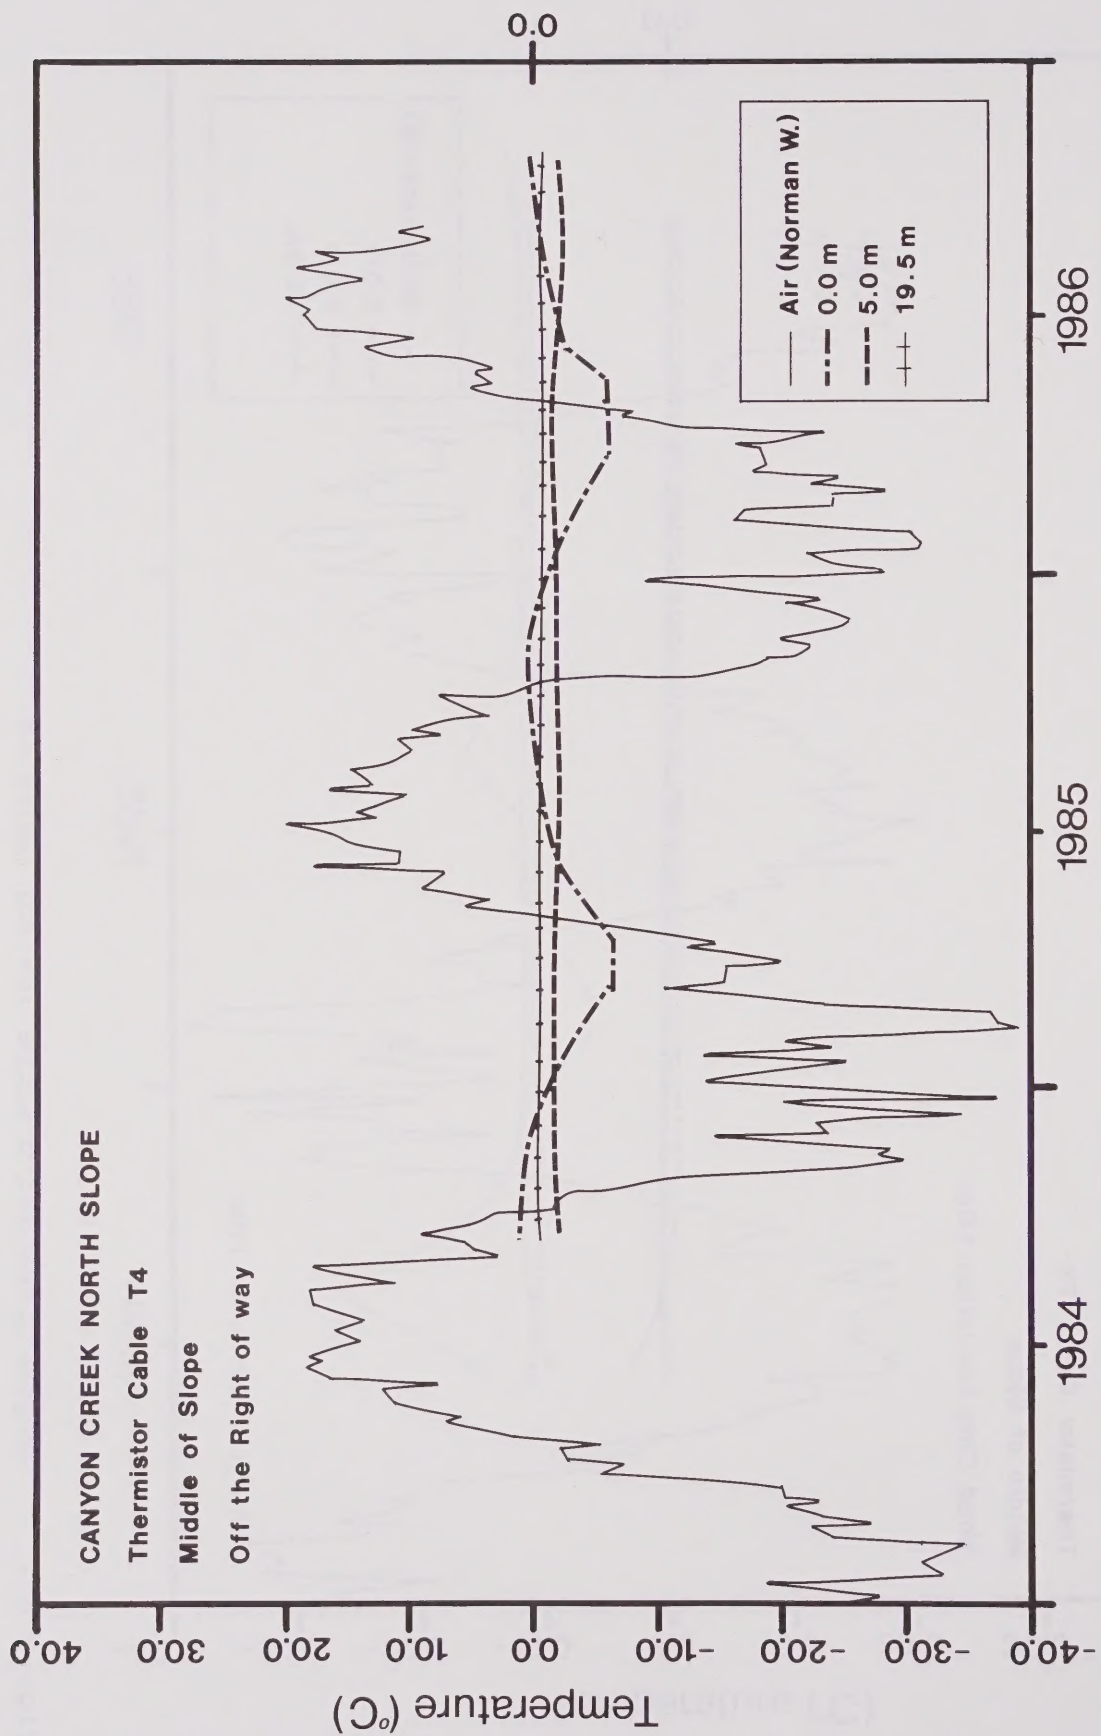
Figure 6-5. Canyon Creek North slope (84-2B) cable T4.

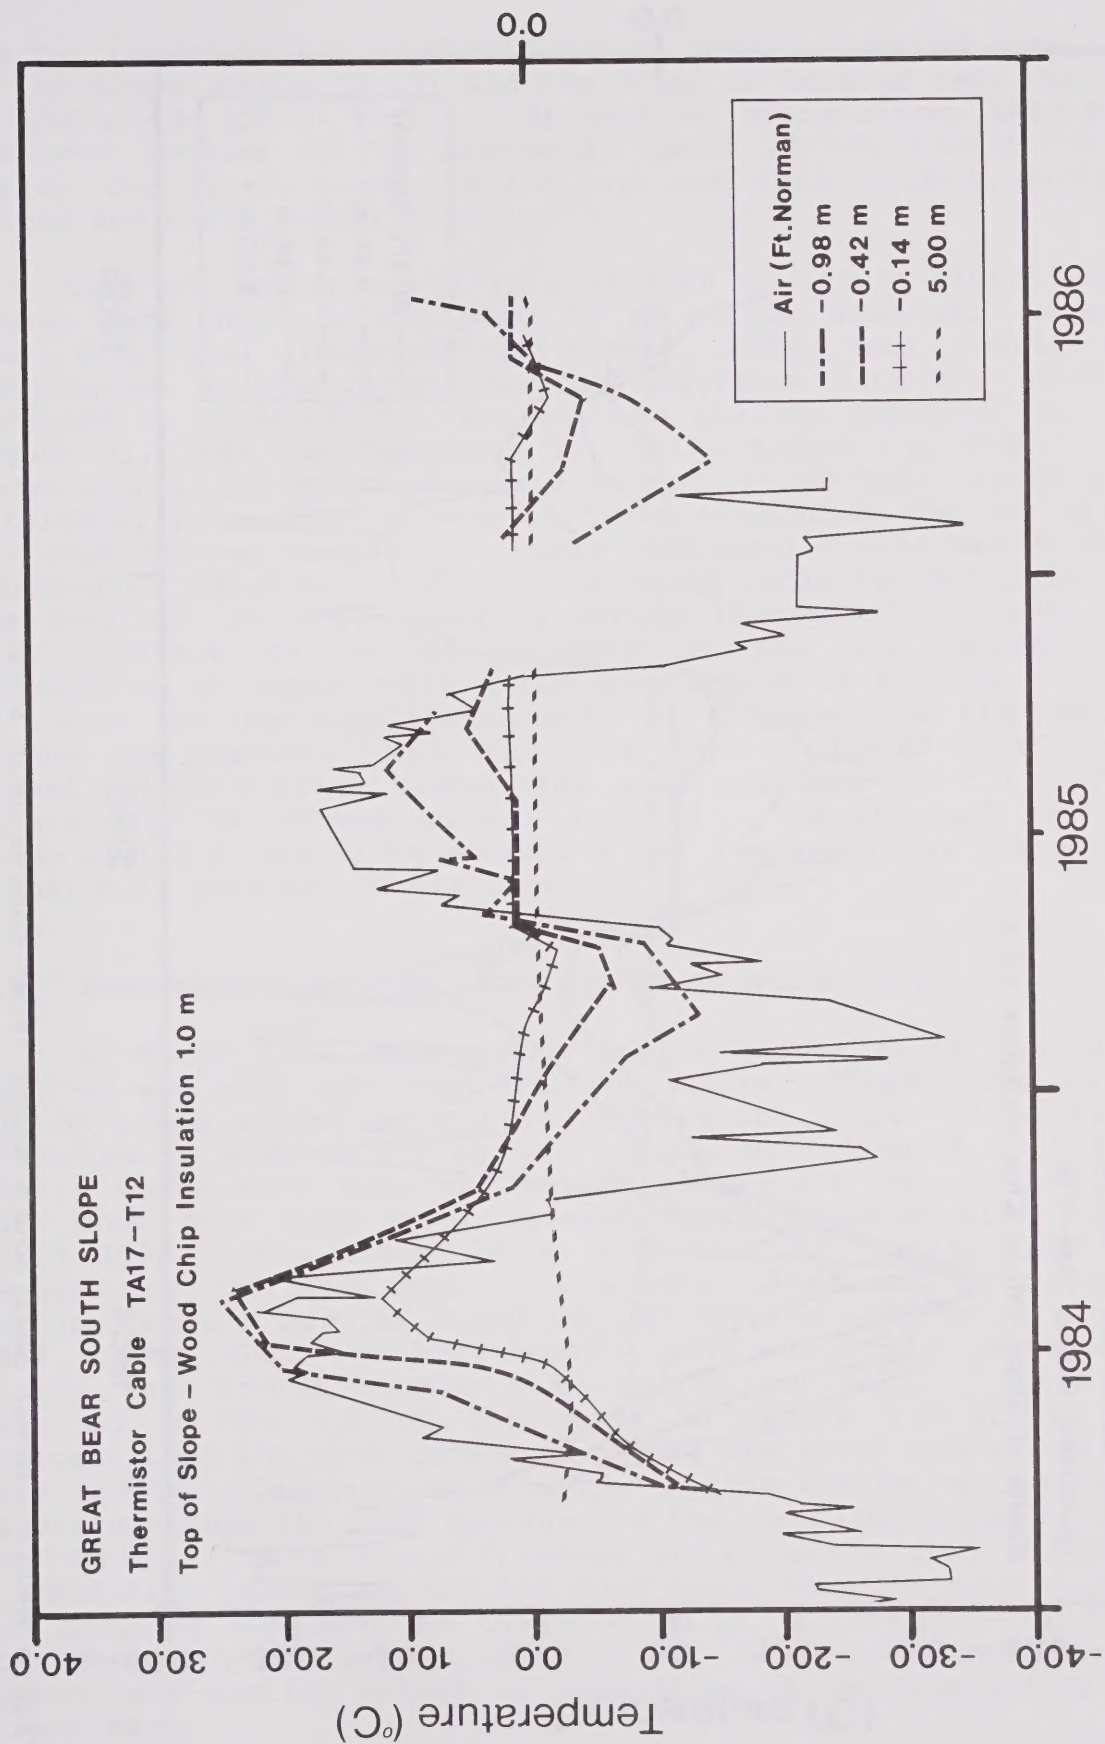
Figure 6-6. Great Bear South slope (#29) cables TA17 & T12.

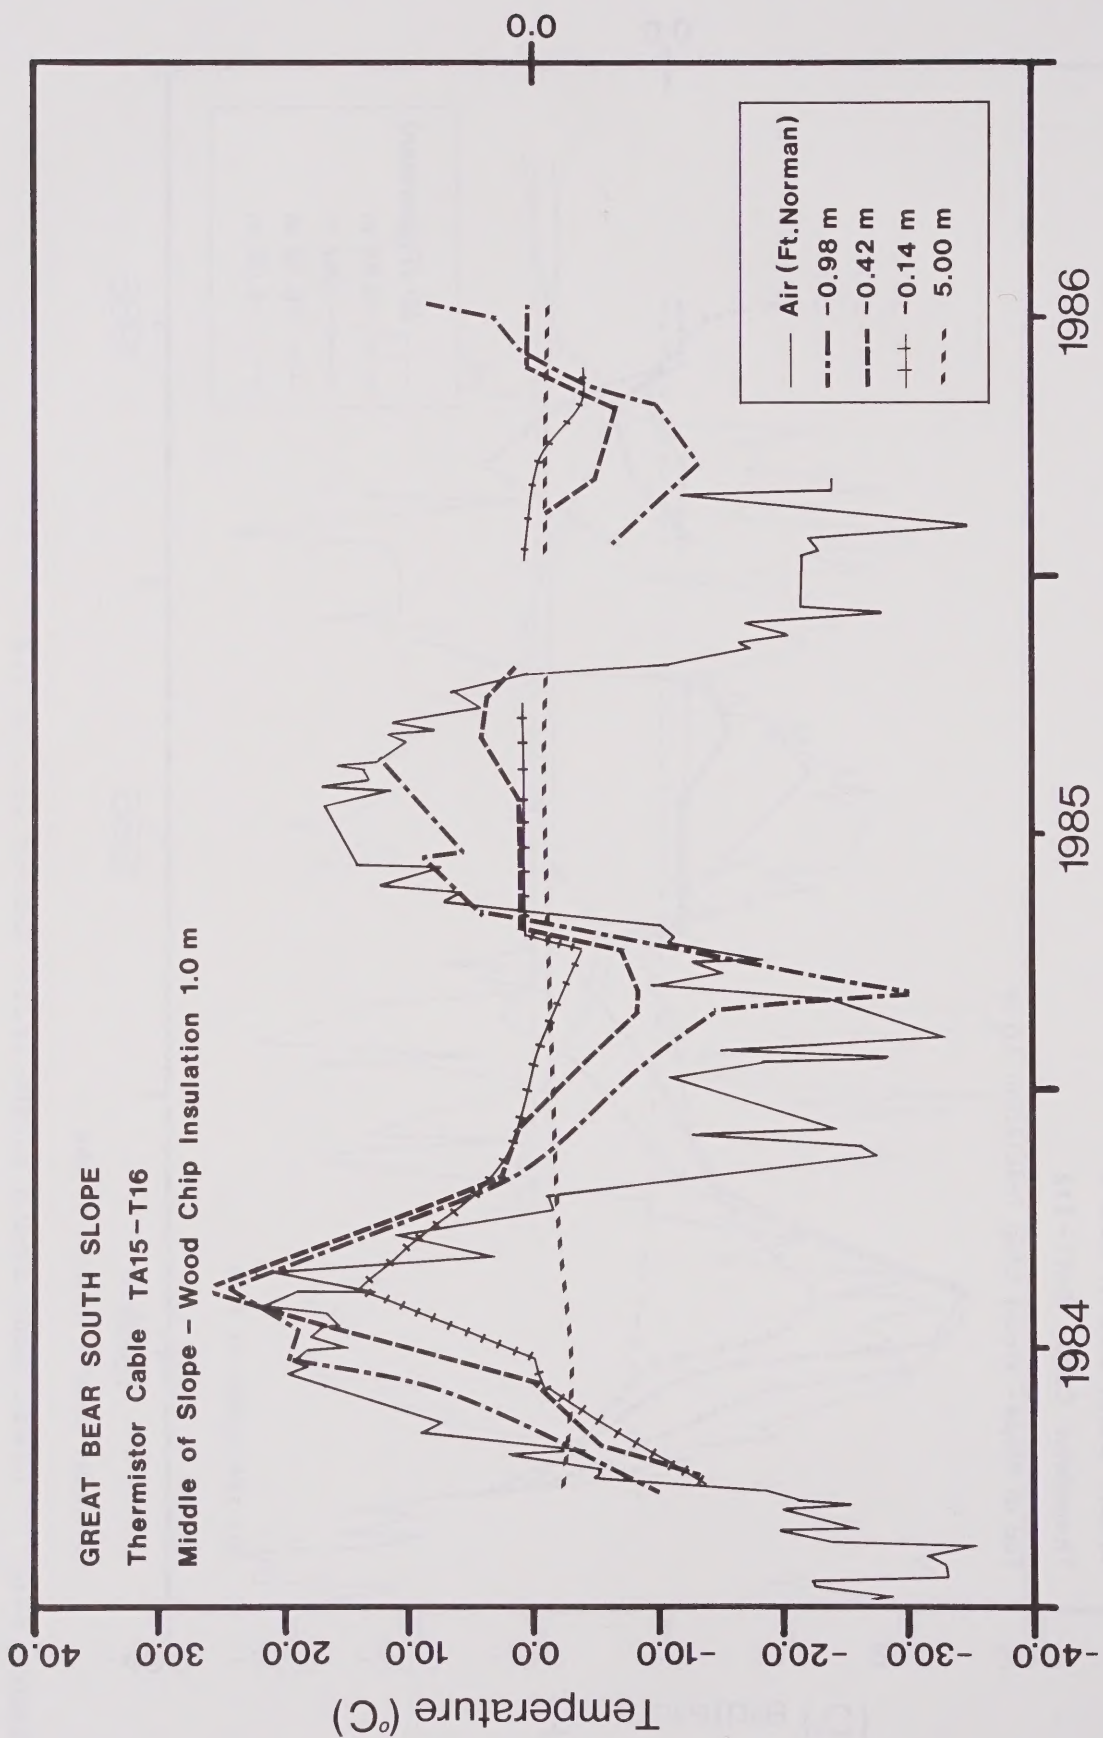
Figure 6-7. Great Bear South slope (#29) cables TA15 & T16.

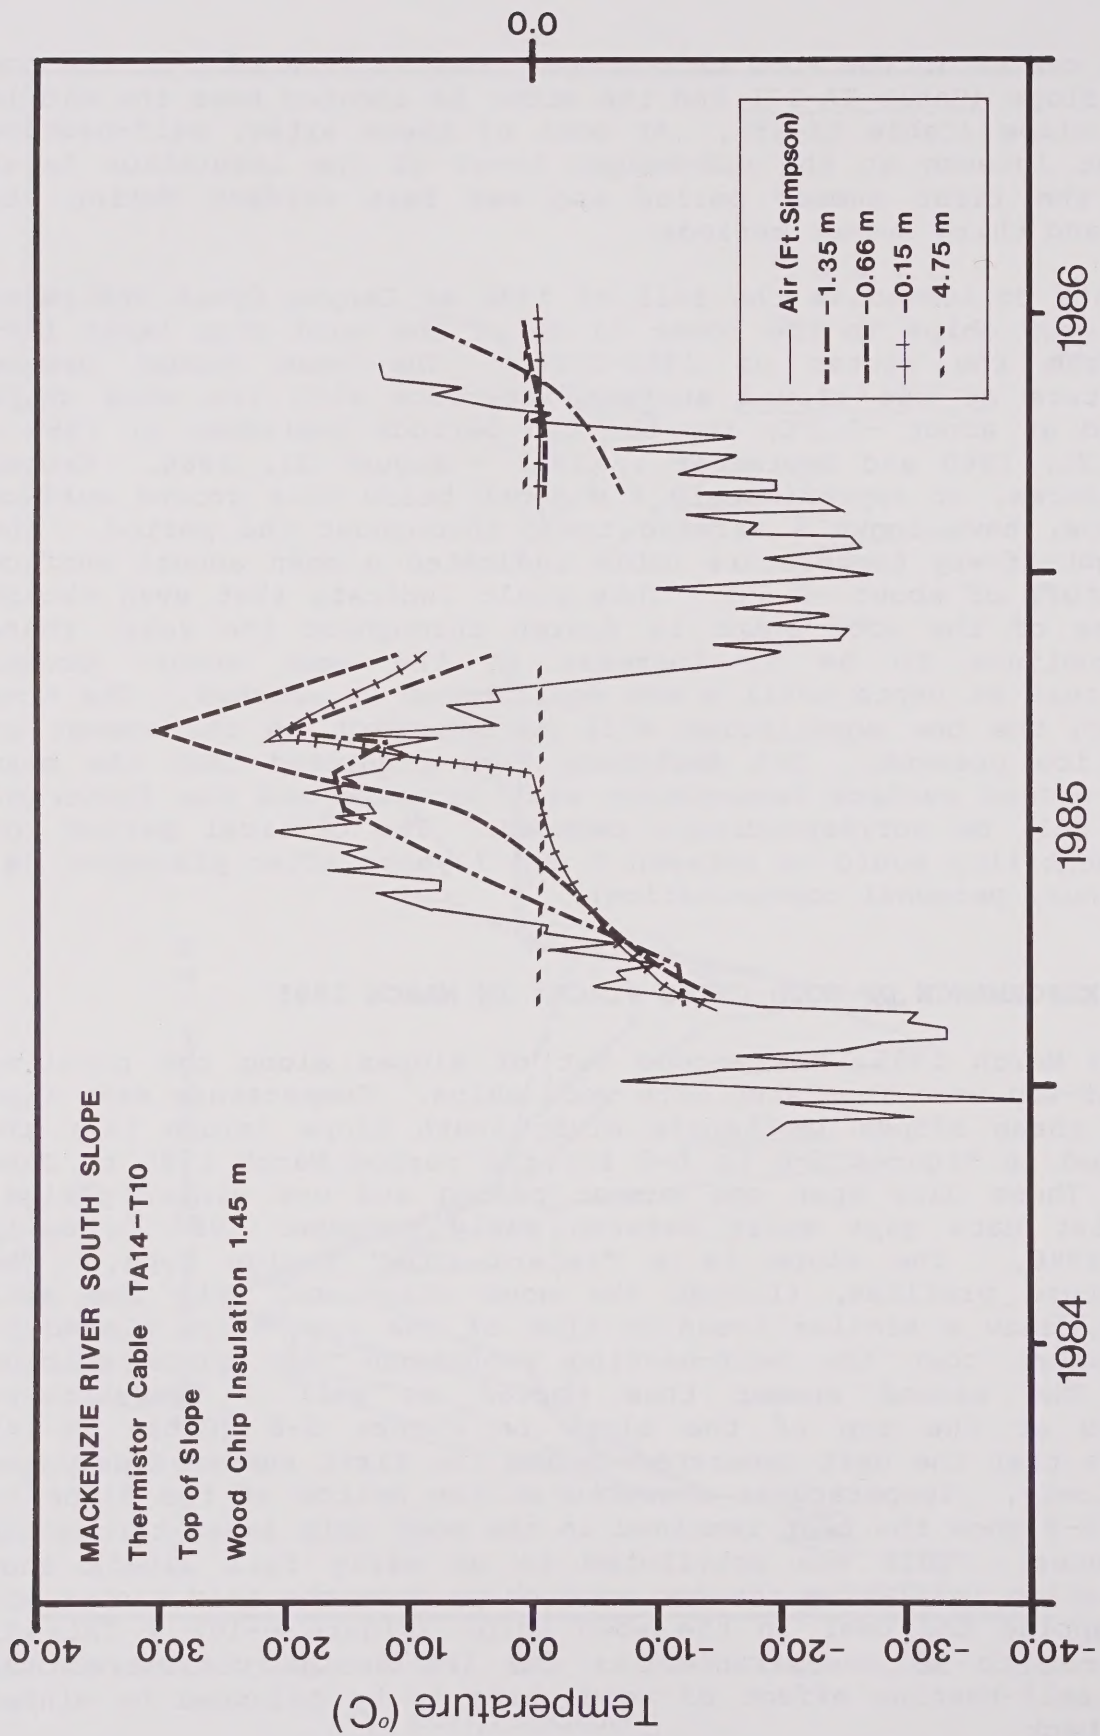
In March 1985, the second set of slopes along the pipeline right-of-way were insulated with wood chips. Temperature data from one of these slopes (Mackenzie River South slope (slope 142) are presented in Figures 6-8 to 6-9 for the period March 1985 to June 1986. These data span one summer period and one winter period. Note that data gaps exist between early November 1985 to early March 1986. The slope is a "retard thaw" design type. The temperature profiles, through the wood chips and into the soil beneath, show a similar trend to that of the wood chips placed in 1984 except that the self-heating phenomenon was quite evident during the second summer thaw period as well. Temperatures measured at the top of the slope in Figure 6-8 (Cable TA-14) indicate that the heat generated during the first summer dissipated very slowly. Temperatures measured at the bottom of the slope in Figure 6-9 show the heat remained in the wood chip layer throughout the winter. This was attributed to an early fall (1985) snow accumulation insulating the hot wood chips from the cold winter air and trapping the heat in the wood chips (Figure 6-10). This is considered to be undesirable, as the IPL design considered the summer self-heating effect of wood chips to be balanced by winter freeze back.

Figure 6-8. Mackenzie River south slope (#142) cables TA14 & T10.

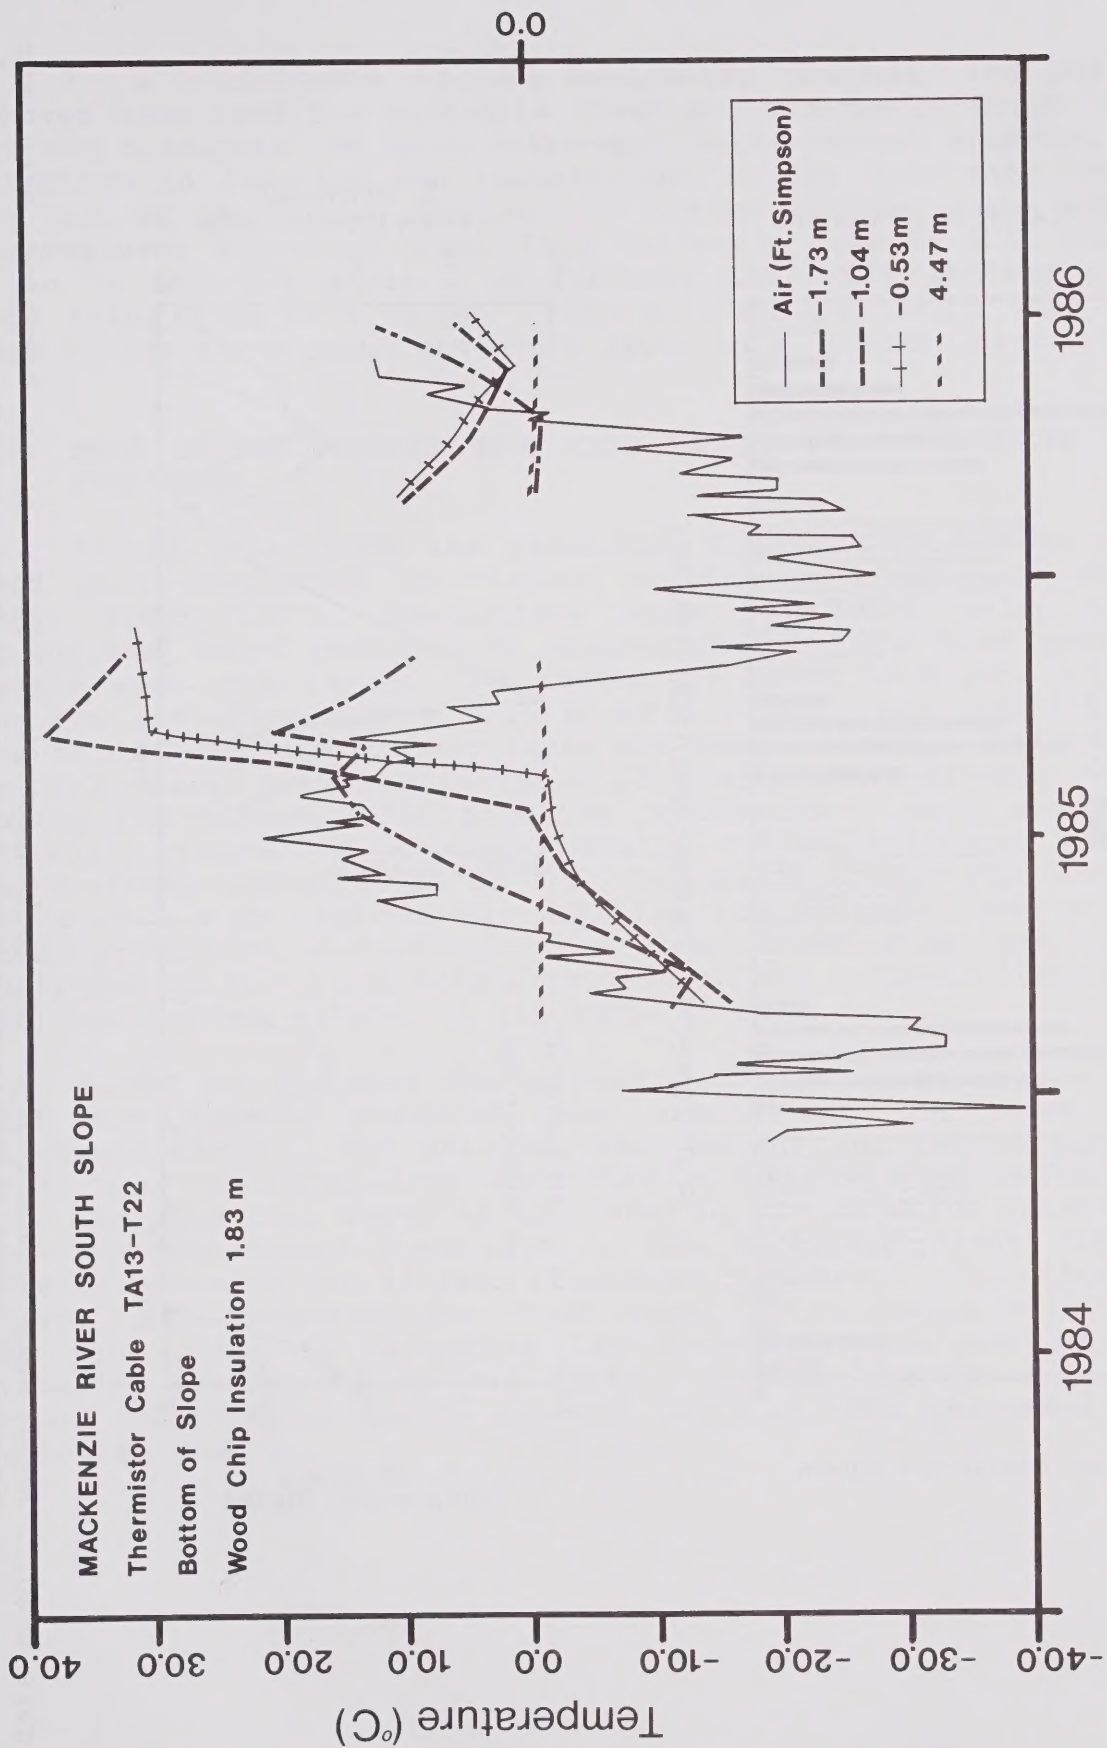
Figure 6-9. Mackenzie River South slope (#142) cables TA13 & T22.
